CALIFORNIA DEPARTMENT OF FORESTRY AND FIRE PROTECTION SONOMA-LAKE NAPA UNIT

INVESTIGATION REPORT

CASE NUMBER: 17CALNU010045

CASE NAME: Tubbs

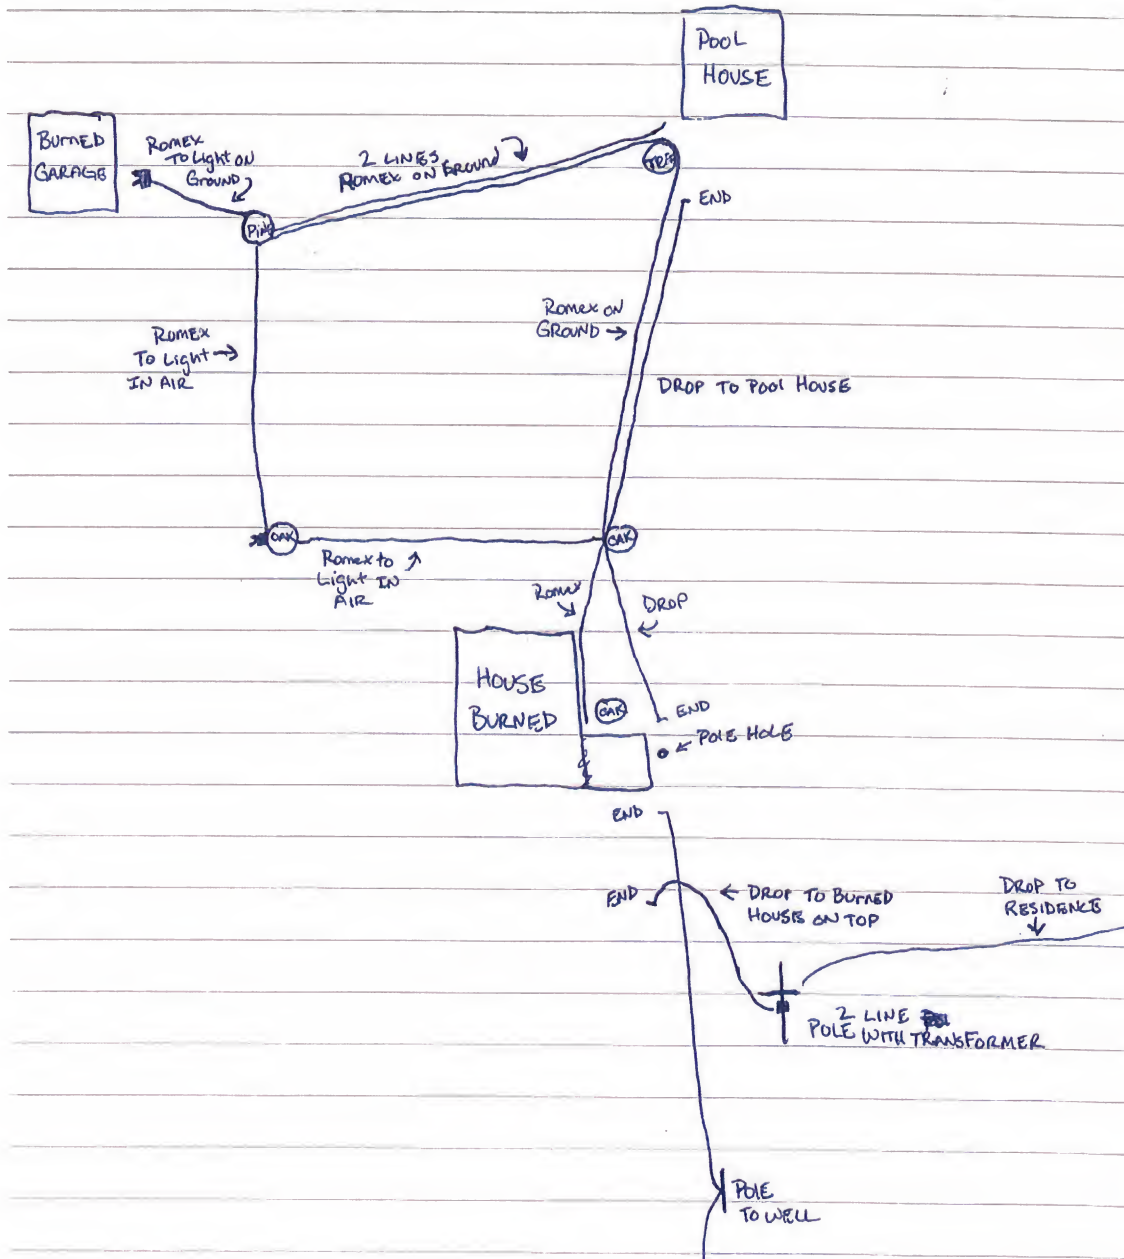
The graphic below includes a general representation of the private electrical system at 1128 Bennett Lane prepared by ROATH.

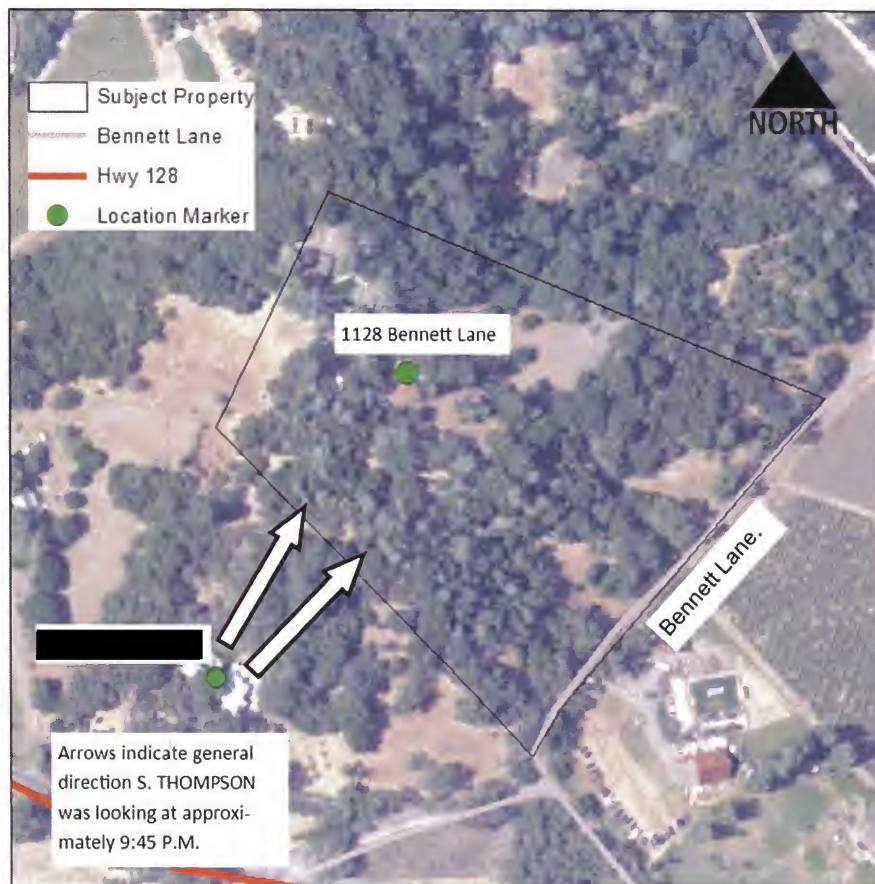
22
23 The 1128 Bennett Lane property is the next adjoining property to the northeast from the
24 S. THOMPSON property. A fire spreading towards the S. THOMPSON residence from
25 his description would likely have come from or passed through the 1128 Bennett Lane
26 property. The graphic below, prepared by MARTINEZ, is a representation, based on
27 the witness statement, showing where the witness was and what direction he was
28 looking.

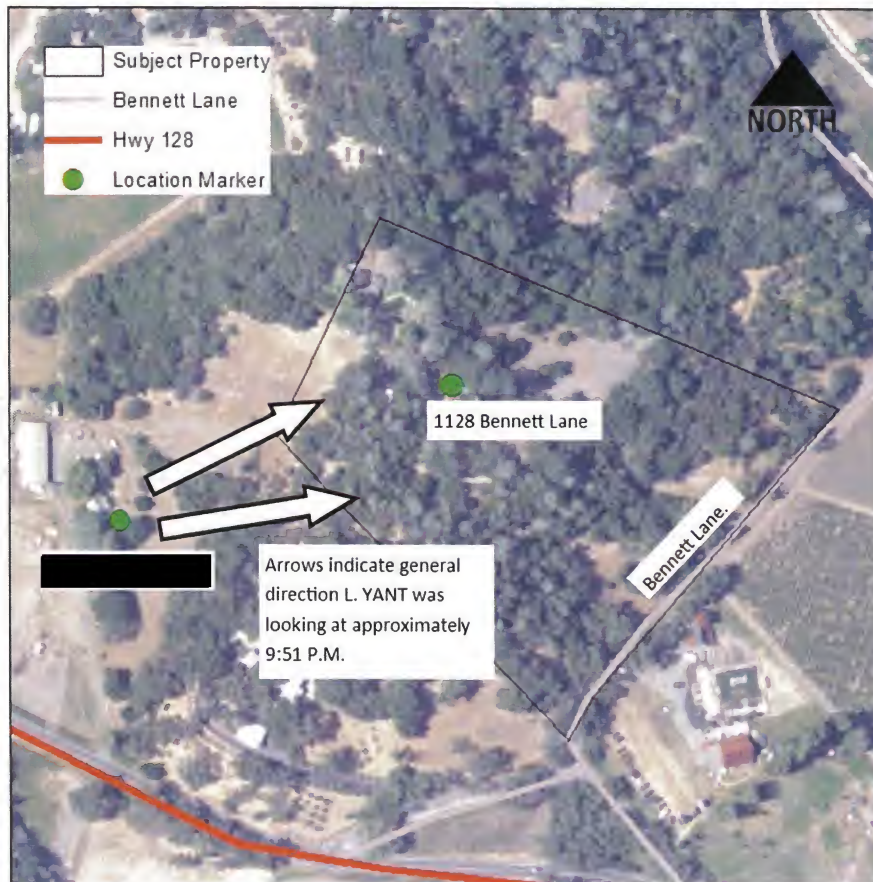
19
20 J. YANT was in Sacramento when the fire started. His wife, Lucinda YANT (L. YANT),
21 was home alone on October 8, 2017. Their son, James Carson YANT (JC. YANT) who
22 lives on Mt. St. Helena, heard on a scanner of a fire located at Tubbs Rd and Hwy 128.
23 JC. YANT sent a text to L. YANT, notifying her of the fire. L. YANT got out of bed and
24 walked out the back porch, facing northeast, and noticed fire burning in a south
25 direction. She took three photographs with her cellular phone at approximately 9:51
26 P.M. (see photographs P-JM-cellular-01 thru P-JM-cellular-03), which she provided to
27 investigators. When she returned into the house she saw through a large window, fire
28 on the other side of the gravel road to the southwest also burning in a south direction.

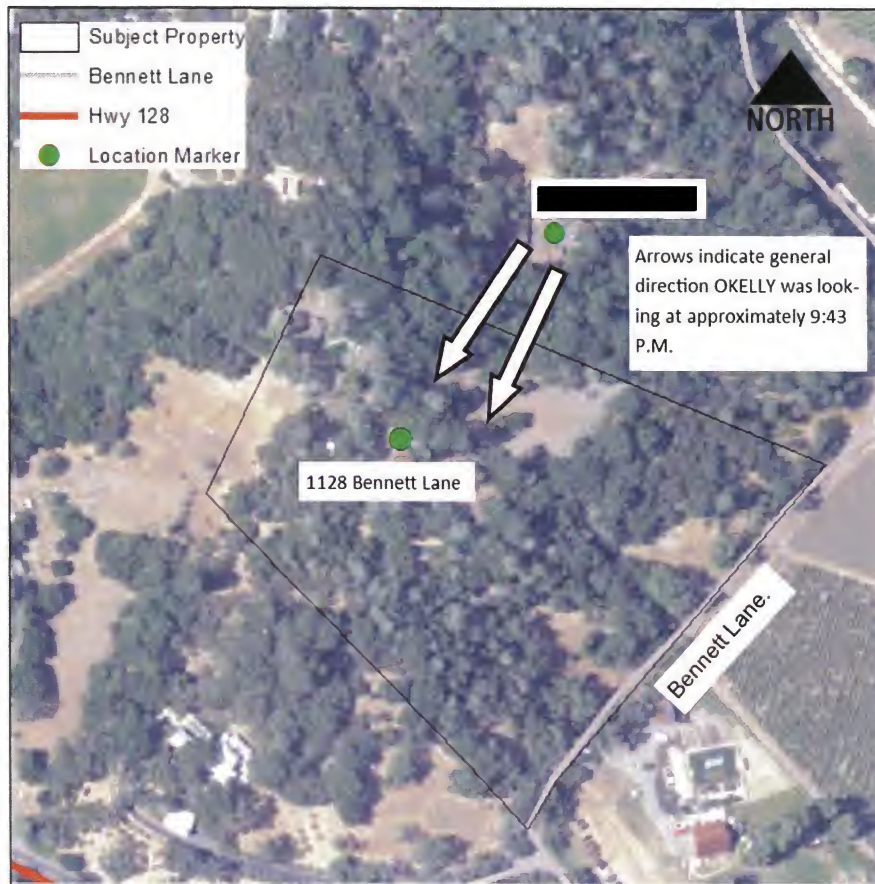
12 OKELLY was home at [REDACTED] on the evening of October 8, 2017. At
13 approximately 9:28 P.M., the power went off. Sometime after 9:43 P.M. she looked out
14 her window and saw fire coming towards her house. She said it was backing down from
15 "above." I asked where "above" was and she said it was from where her power comes
16 from. I confirmed with her she was referring to the 1128 Bennett Lane Property. The
17 fire had not wrapped around the west or east side of her residence when she left at
18 approximately 10:15 P.M.

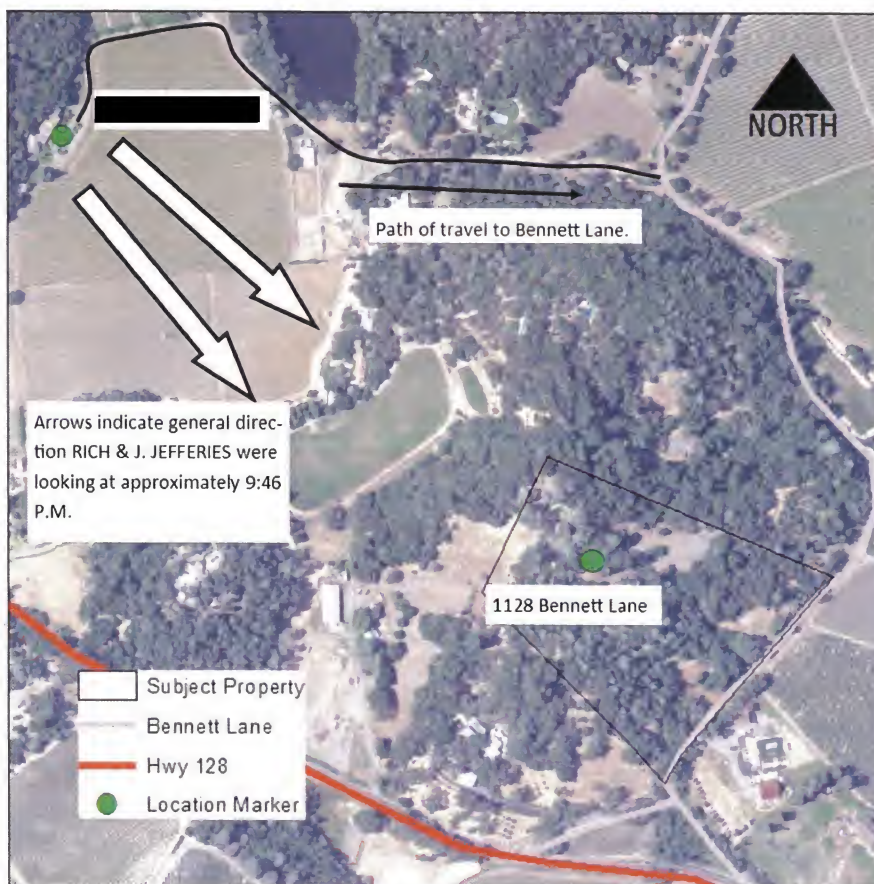
The 1128 Bennett Lane property is approximately .7 miles southeast of the RICH property. The first visible hills to the southeast of the RICH property include the area of 1128 Bennett Lane.

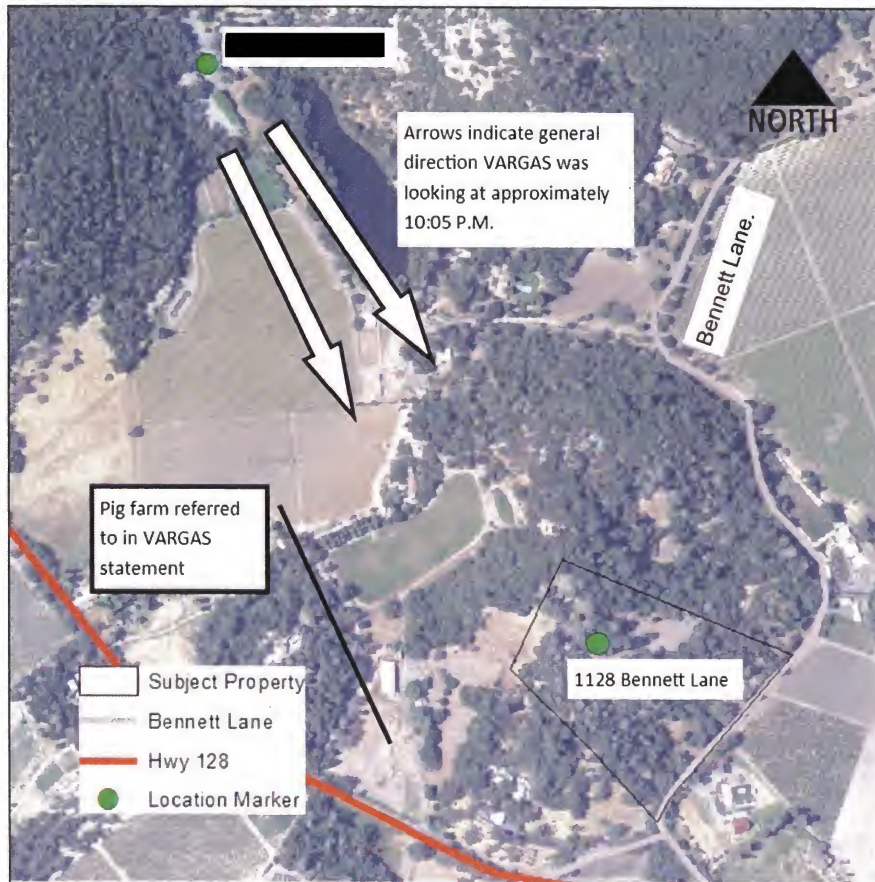
1 approximately 10:05 P.M., he went outside and noticed a fire on the hill above the pig
2 farm (YANT residence). He departed his residence at approximately 12:00 A.M. and
3 saw the fire on the hill to his right while exiting on the road that ties into Bennett Lane.
4 He did not notice fire on his left side (north) while exiting. The hillside above the YANT
5 residence at [REDACTED] includes both the 1110 and 1128 Bennett Lane properties.
